YOUR INSPECTION REPORT

443 Madison Cres
Chicago, IL

INSPECTION DATE:
Monday, January 7, 2013

RE: Report No. 1366, v.28
443 Madison Cres
Chicago, IL

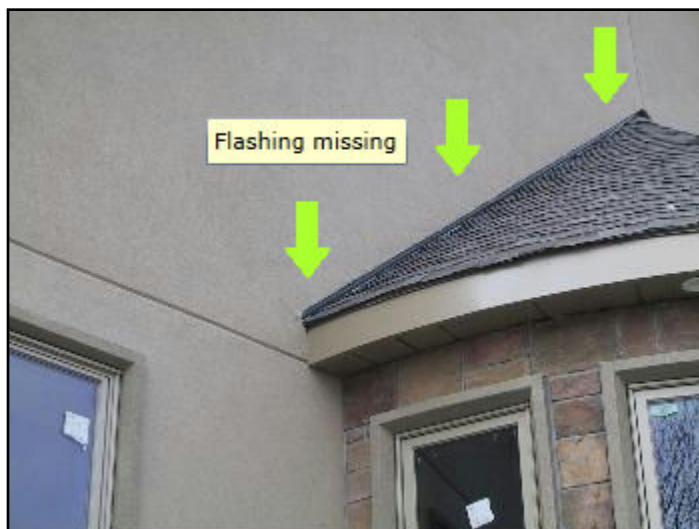
2. **Condition:** • [No kickout flashing](#)

Implication(s): Chance of water damage to contents, finishes and/or structure

Location: North First floor

1. No kickout flashing at roof/sidewall junction

Task: Improve

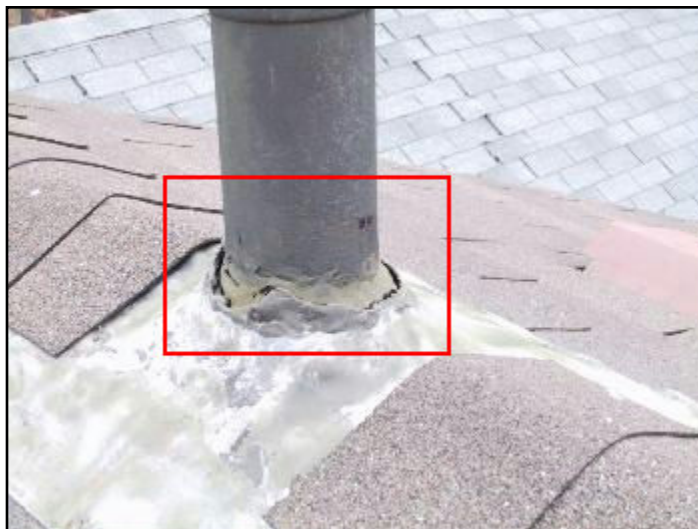
3. Condition: • [Leak](#)

Implication(s): Chance of water damage to contents, finishes and/or structure

Location: North

2. Stack flashing should be sealed.

Task: Repair

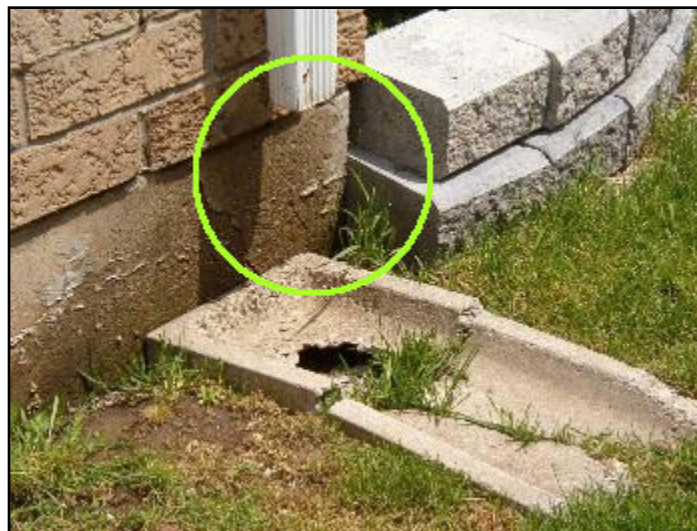
5. **Condition:** • [Downspouts end too close to building](#)

Implication(s): Chance of water damage to contents, finishes and/or structure

Location: East Exterior wall

3. Downspout should be extended away from home

The downspout should be extended to discharge at least 6 feet from the home. The broken splash block can be discarded.

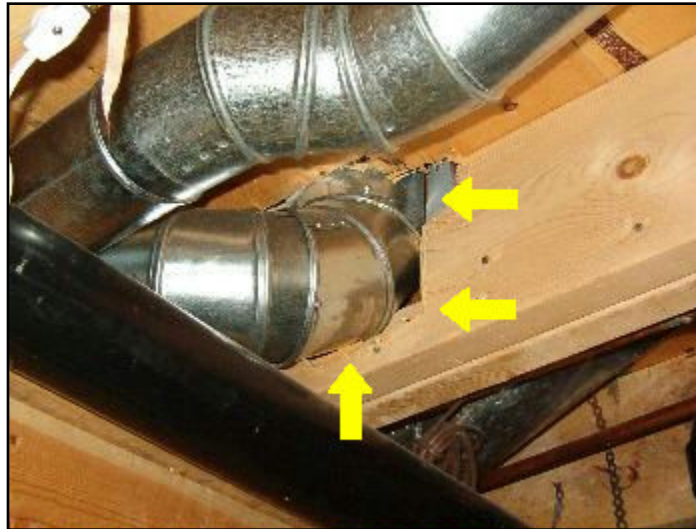
6. Condition: • [Notches or holes](#)

Implication(s): Weakened structure

Location: West Basement

4. Double joist cut for ductwork

Task: Repair

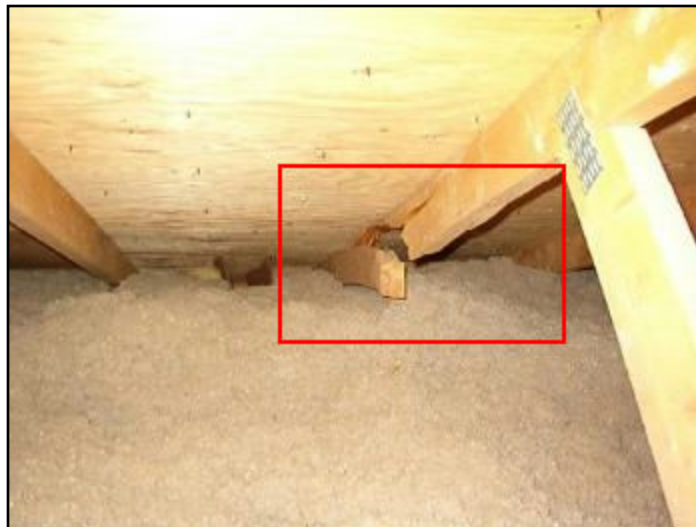
7. Condition: • [Split](#)

Implication(s): Weakened structure | Chance of structural movement

Location: Northeast Attic

5. Top chord of truss is broken

Task: Repair or replace

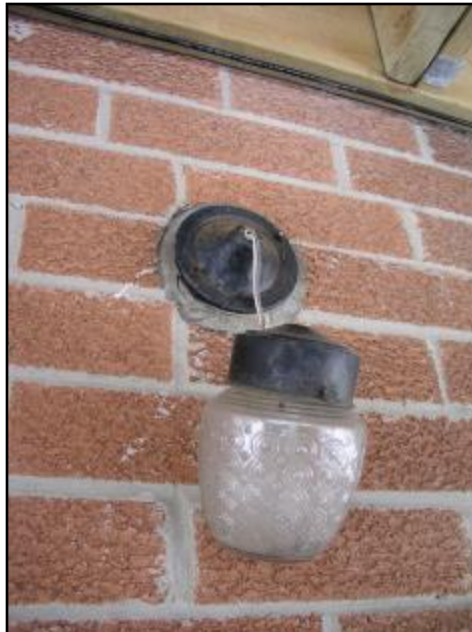
10. Condition: • [Loose](#)

Implication(s): Electric shock | Fire hazard

Location: East Exterior wall

7. Light fixture is not well secured

Task: Repair or replace

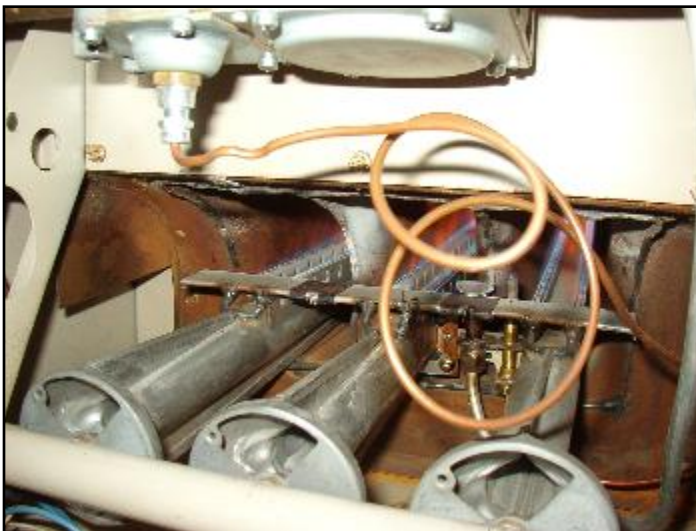
9. Rust at bottom of heat exchanger

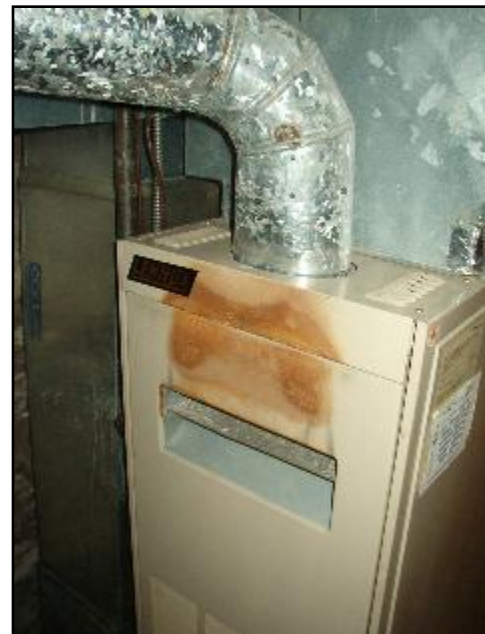
13. Condition: • [Draft hood spillage or backdraft](#)

Implication(s): Equipment not operating properly | Hazardous combustion products entering home

Location: Basement Furnace room

10. Evidence of furnace backdrafting

Task: Correct

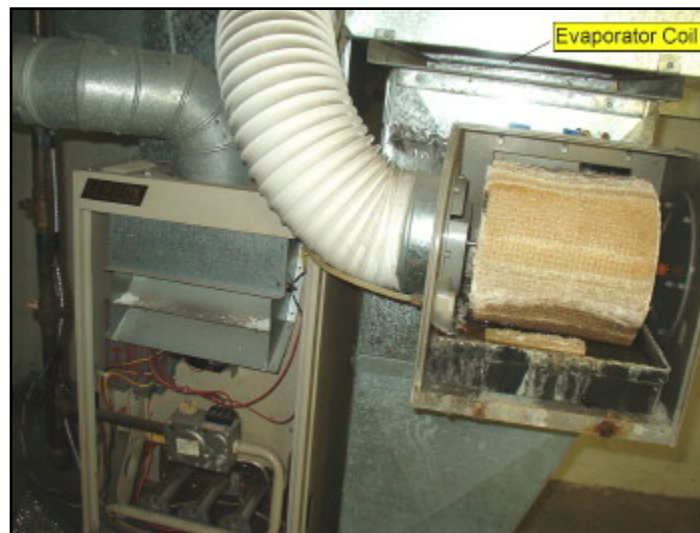
14. Condition: • [Leak](#)

Implication(s): Chance of water damage to contents, finishes and/or structure | Damage to equipment

Location: West Basement

11. Leaking and inoperative humidifier

Task: Repair or replace

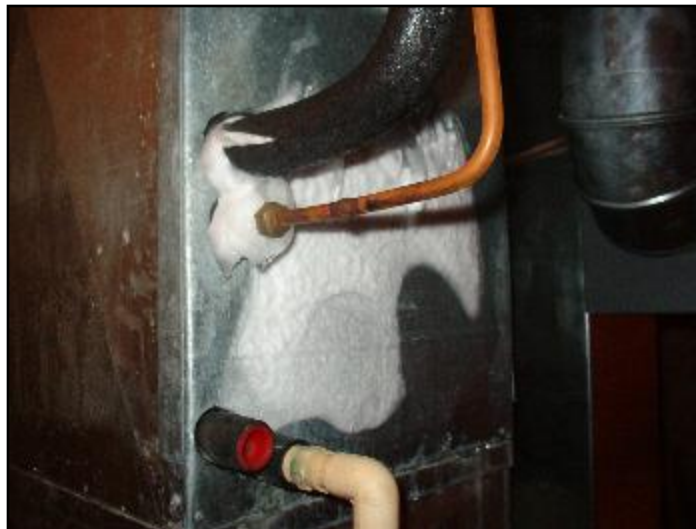
15. Condition: • [Frost](#)

Implication(s): Increased cooling costs | Reduced comfort

Location: West Basement

12. Frost visible on ductwork at AC coil

Task: Repair

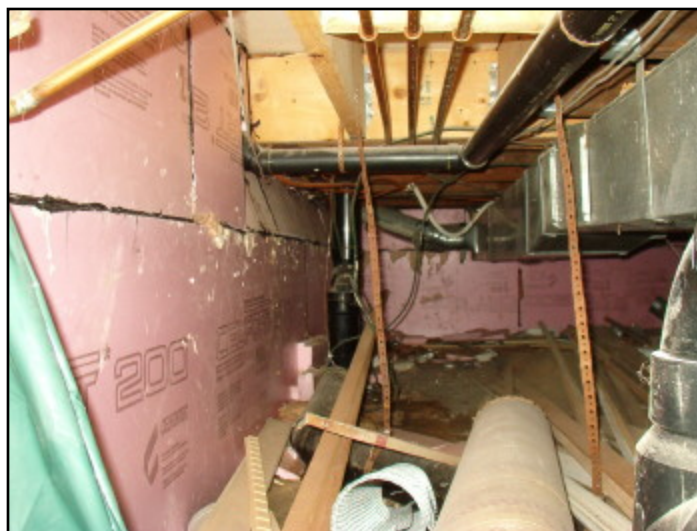
16. Condition: • [Exposed combustible insulation](#)

Implication(s): Fire hazard

Location: West Crawl space

13. *Exposed polystyrene insulation is fire hazard*

Task: Remove or cover with drywall

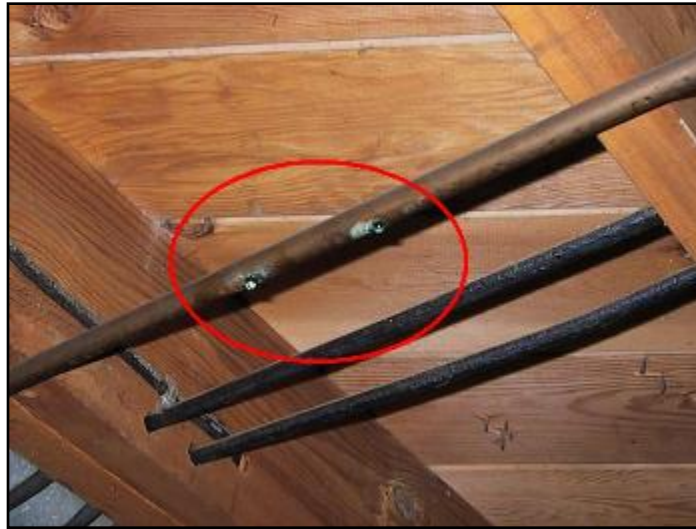
17. Condition: • [Leak](#)

Implication(s): Chance of water damage to contents, finishes and/or structure | System inoperative

Location: Northeast Basement

14. Leaking copper supply pipe

Task: Repair

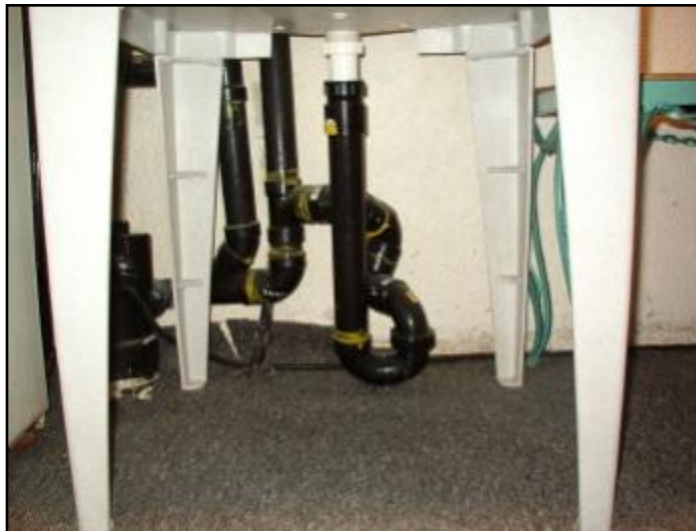
18. Condition: • [Nonstandard shape or material](#)

This configuration is prone to clogging problems

Implication(s): Reduced operability | Fixtures slow to drain

Location: Basement Laundry area

15. Poor trap arrangement

Task: Improve

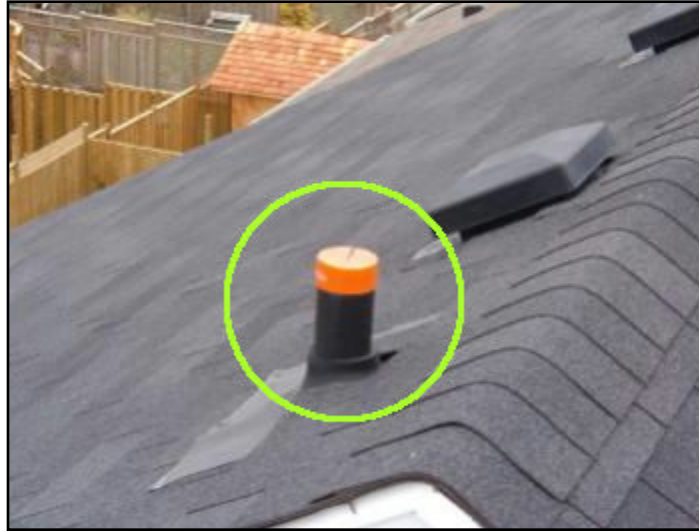
19. Condition: • [Vent termination problems](#)

Implication(s): Reduced operability | Sewer gases entering the house

Location: West central part of roof

16. Plumbing stack is capped

Task: Remove cap

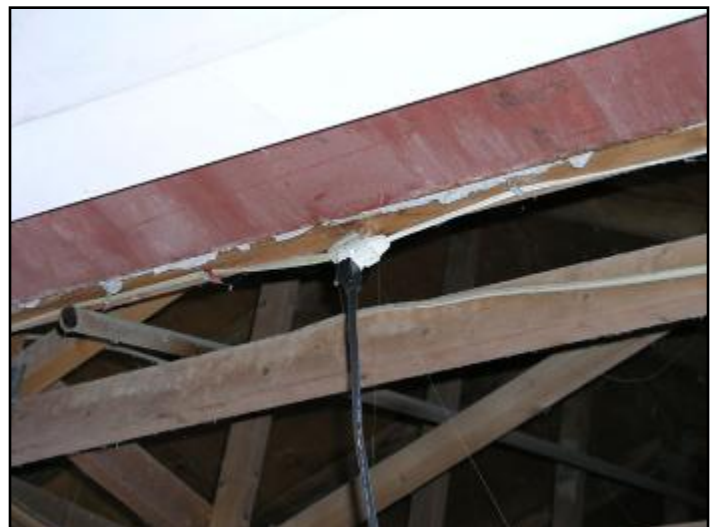
21. Condition: • [Extension cord for opener](#)

Implication(s): Electric shock

18. Extension cord for east garage door opener

Task: Replace with permanent wiring
