YOUR INSPECTION REPORT

443 Madison Cres
Chicago, IL

INSPECTION DATE:
Monday, January 7, 2013

RE: Report No. 1366, v.28
443 Madison Cres
Chicago, IL

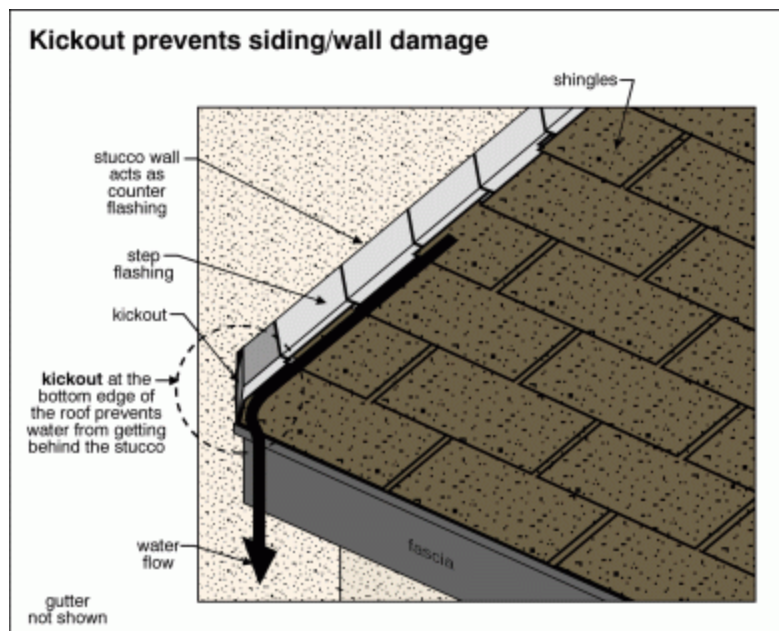
2. **Condition:** • [No kickout flashing](#)

Implication(s): Chance of water damage to contents, finishes and/or structure

Task: Improve

Time: Less than 1 year

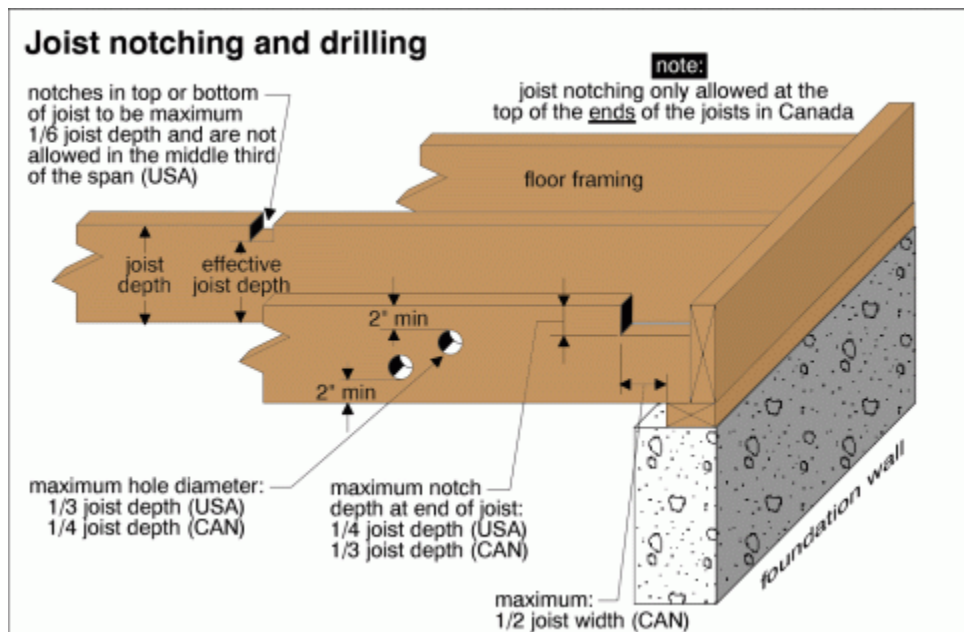
6. Condition: • [Notches or holes](#)

Task: Repair

Time: Immediate
